Nondestructive Testing Technologies and Applications for Detecting, Sizing and Monitoring Corrosion/Erosion Damage in Oil & Gas Assets

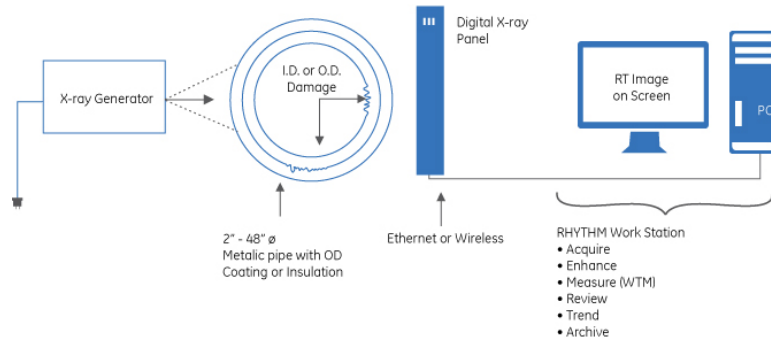
Figure 1: Illustration of digital x-ray functionality.

This type of inspection is enabled by formless, flat panel detectors. Light is converted and emitted by the absorption of x-ray photons by the cesium iodide scintillator. A low-noise photodiode array, where each photodiode represents a pixel, absorbs the light and subsequently translates it into an electronic charge. Finally, low-noise digital electronics read out the charge at each pixel.

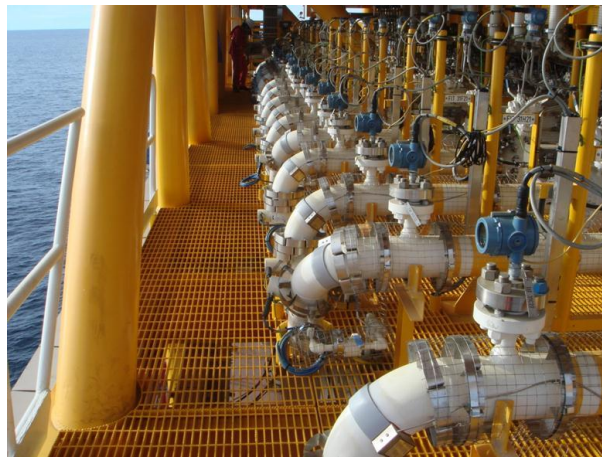
Figure 11: Installed transducer pads on critical elbows at an offshore production platform.

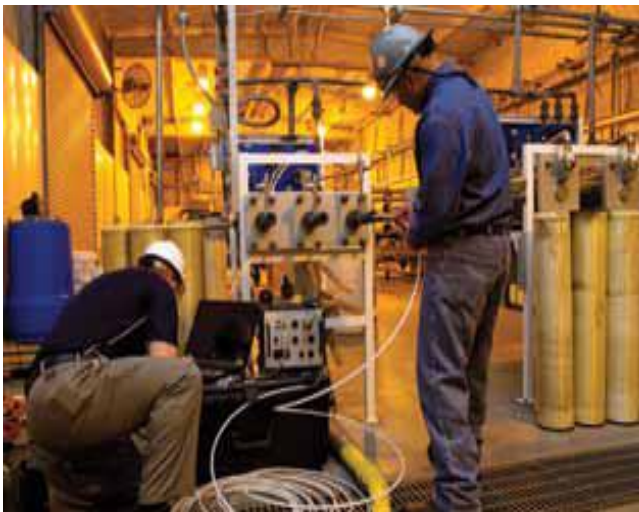
Figure 12 (left): Field inspection of specialized heat exchanger tubes at a chemical plant using eddy current technology.

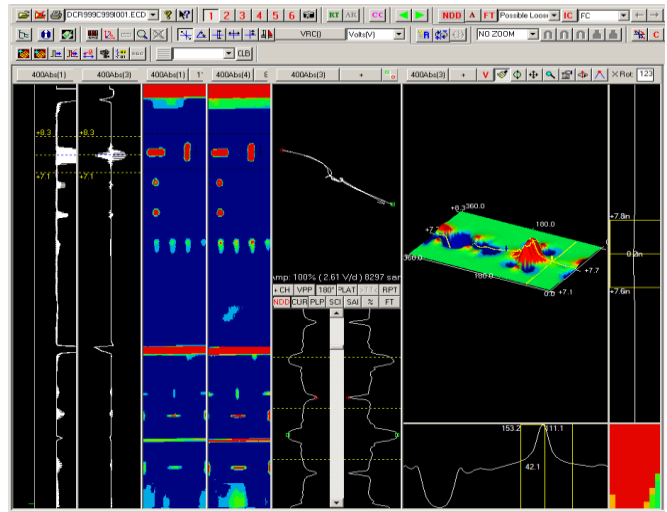
Figure 13 (right): Eddy current graphic of a Terrain Plot of data demonstrating detected wall thinning, pitting, erosion, and cracking.
