Nondestructive Testing Technologies and Applications for Detecting, Sizing and Monitoring Corrosion/Erosion Damage in Oil & Gas Assets

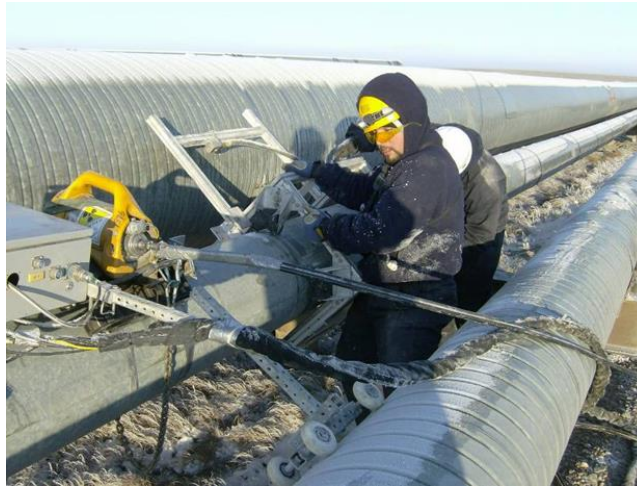
Figure 2: Field deployment of digital x-ray (DXR) imaging system for insulated pipe inspection.

Portable, digital radiography has had a profound impact on the work of inspection companies in a variety of field applications. This technique was discovered to be an effective solution to the challenge of CUI detection in harsh climates and on aged assets. Portable DR used with an electro-mechanical crawler provides the inspector with the ability to perform 100% inspection, for extensive sections of horizontal pipeline, detecting and sizing both ID and OD metal loss.

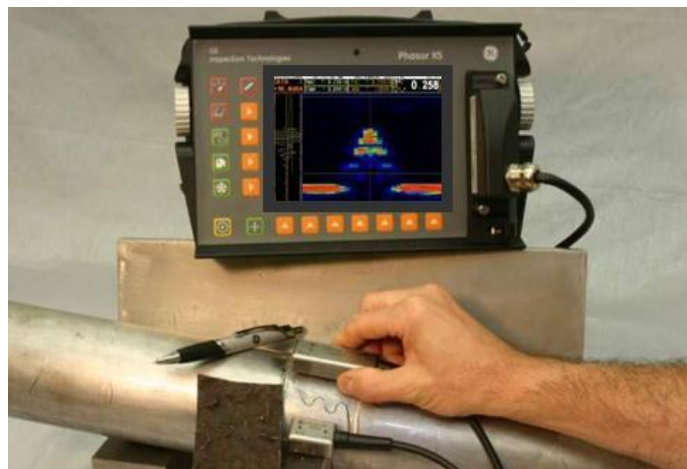
Figure 7 (upper-left): Conventional UT transducer inspection requires more scanning and limits the area covered during flaw-pit detection and sizing.

Figure 8 (lower-left and right): PAUT system electronically profiles the defect, allowing for faster inspections, increased area coverage and improved pit sizing.

The phased-array dual transducer ultrasound technology was recently developed in response to these challenges. The system has the ability to transmit a signal that can penetrate the piping wall or tank bottom, reflect, and be picked up by multiple receiver elements. The v-path created by the phased-array dual transducer makes it possible to identify the size and dimensions of the pit much more precisely than conventional transducers.

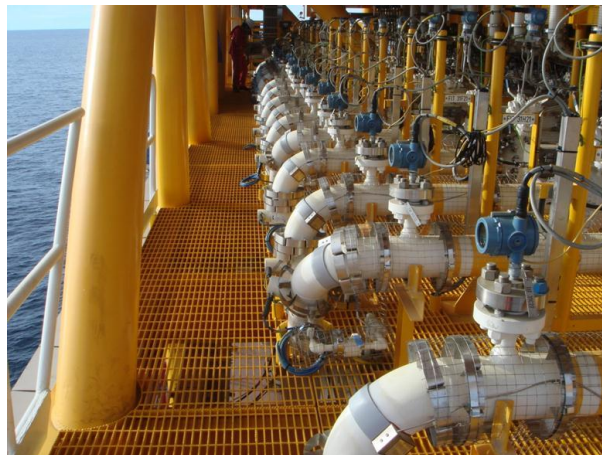
Figure 11: Installed transducer pads on critical elbows at an offshore production platform.

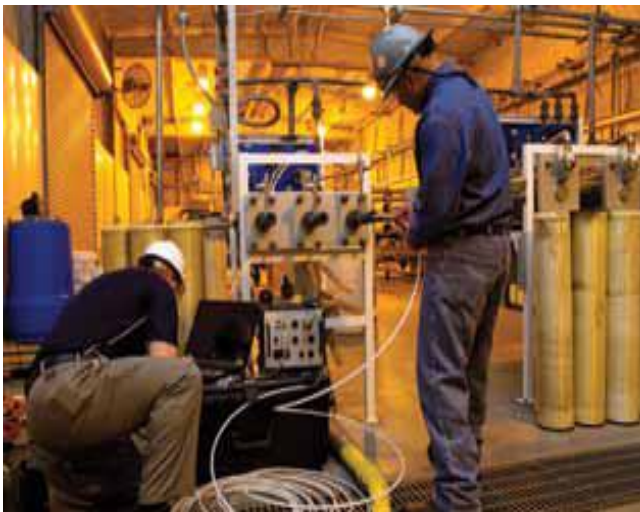
Figure 12 (left): Field inspection of specialized heat exchanger tubes at a chemical plant using eddy current technology.

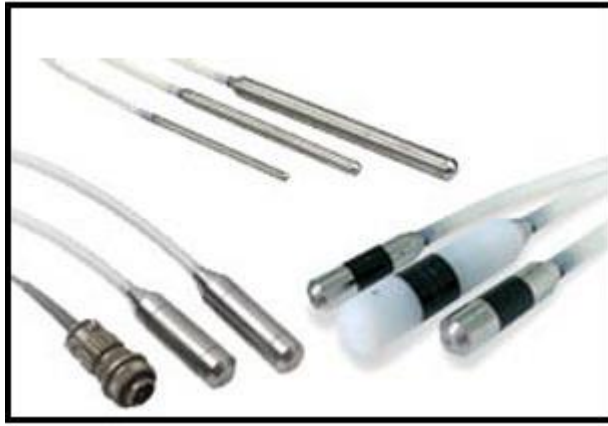
Figure 14: New-to-market detachable ECT tube ID probes which enable lower-cost HX tube inspections.

A variety of probes exist for eddy current testing. For heat exchanger corrosion detection, there are several benefits to using motorized rotating pancake coil and/or array probes. Advantages include circumferential crack detection, improved ID-initiated crack sizing, detection of either single or multiple cracking in the same plane/axis and improved volumetric damage sensitivity. In addition, Near Field Testing (NFT) is primarily used for the inspection of carbon steel tubes with aluminum fins. NFT allows for the detection and sizing of ID pitting and erosion defects.

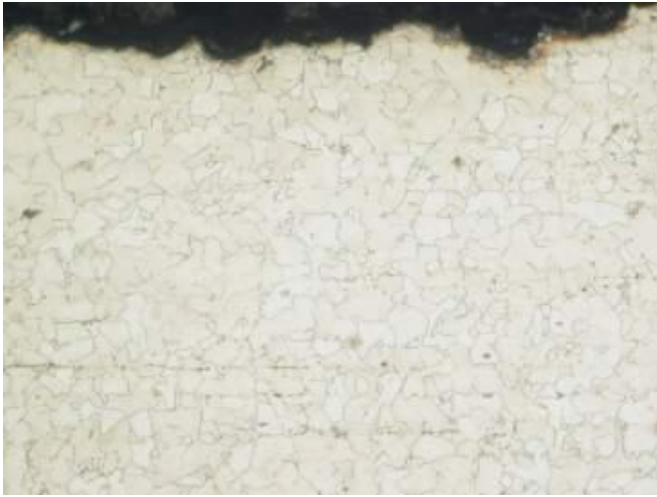
Figure 15 (left): A pipe ID surface exhibiting complete decarburization of the original structure, magnified at 200X.

Steel which is exposed to hydrogen attack conditions will pass through an incubation period before actual attack is initiated. During the incubation period, steel which has absorbed hydrogen may suffer a loss in ductility which can be restored by a relatively low temperature heat treatment. While undergoing this incubation exposure, no changes in structure, composition, or physical properties can be detected. After incubation, hydrogen attack is characterized by decarburization and formation of methane as shown in Figures 14 and 15. Further attack produces more decarburization, fissuring at grain boundaries and eventual crack formation in the structure.
